| Single & Double Layer Assemblies | | COMPARE | Simple Saver® System | |

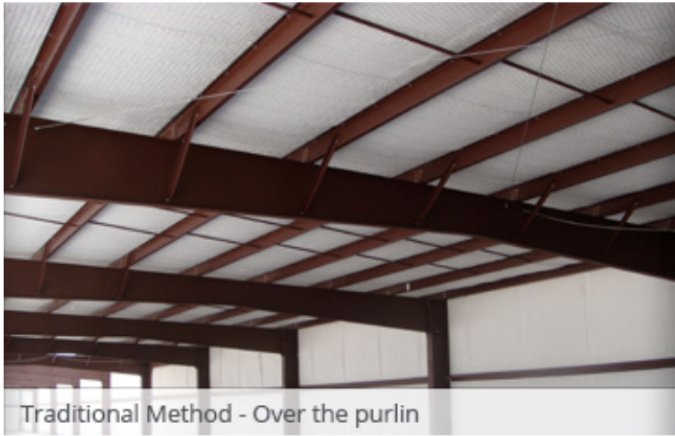
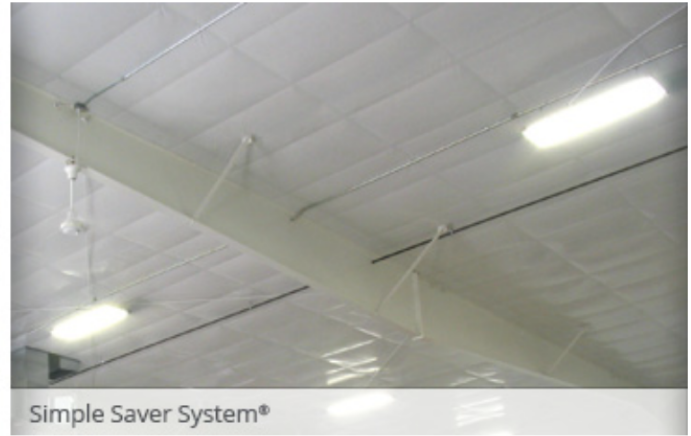
| Single & Double Layer Assemblies | | COMPARE | Simple Saver® System | |
|---|---|---|---|---|
| Insulation is compressed throughout entire purlin cavity and directly above the purlins | Severe | INSULATION COMPRESSION | Minimal | Full designed thickness of lower layers of insulation and top layer of insulation is slightly compressed at purlins |
| Purlins are left exposed to the interior and require painting for a consistent, finished appearance | Unfinished | APPEARANCE | Finished | Purlins are hidden and the liner system creates a clean, finished ceiling grid appearance |
| Improper placement outside of dew point line may result in condensation and corrosion | Defective | VAPOR RETARDER PLACEMENT | Correct | Properly placed below the purlins to help prevent condensation and corrosion |
| The integrity of the vapor retarder is compromised by stapled or poorly sealed seams every few feet | Interrupted | VAPOR RETARDER INTEGRITY | Continuous | Custom sized vapor retarder typically spans the entire bay and is sealed to primary building structure |
| Laminated facings have a variety of strength and durability limitations | Varies | VAPOR RETARDER STRENGTH | Durable | Fabric liner is engineered to be strong and durable for longevity and job site safety |
